Contract #: 04-0120F4Cty: SF/ALA Rte: 80 PM: 13.2/13.9File #: 69.28**WELDING INSPECTION REPORT****Resident Engineer:**Siegenthaler, Peter**Address:** 333 Burma Road**City:** Oakland, CA 94607**Report No:** WIR-025255**Date Inspected:** 01-Jul-2011**Project Name:** SAS Superstructure**OSM Arrival Time:** 1500**Prime Contractor:** American Bridge/Fluor Enterprises, a JV**OSM Departure Time:** 300**Contractor:** Zhenhua Port Machinery Company, Ltd (ZPMC), Changxing Island **Location:** Shanghai, China**CWI Name:** See Below**CWI Present:** Yes No**Inspected CWI report:** Yes No N/A**Rod Oven in Use:** Yes No N/A**Electrode to specification:** Yes No N/A**Weld Procedures Followed:** Yes No N/A**Qualified Welders:** Yes No N/A**Verified Joint Fit-up:** Yes No N/A**Approved Drawings:** Yes No N/A**Approved WPS:** Yes No N/A**Delayed / Cancelled:** Yes No N/A**Bridge No:** 34-0006**Component:** OBG**Summary of Items Observed:**

Trial Assembly

WELDING INSPECTION REPORT

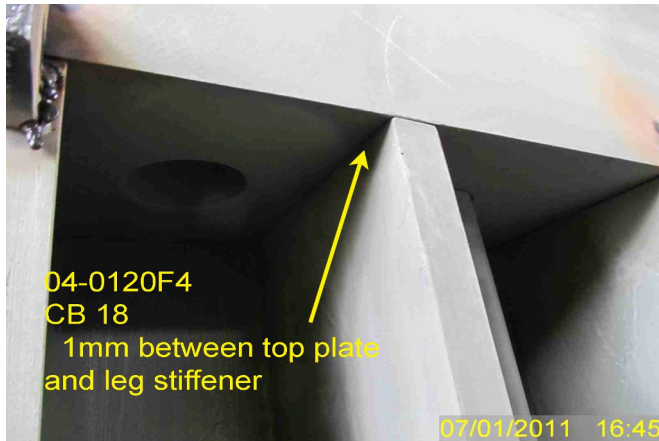
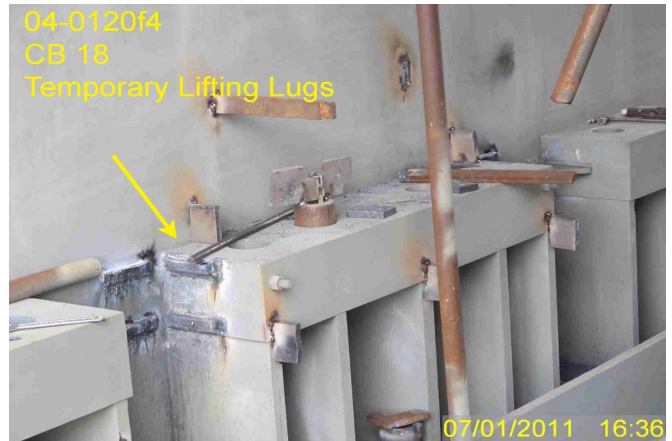
This QA inspector performed a random observation for the OBG. During the observation performed it was noted ZPMC was in process of SMAW welding and grinding on fit-up aids for temporary lifting lug assembly on CB18. The assemblies were observed to have 1mm gap between lifting lug top plate and leg stiffeners, and this was observed by ZPMC/ ABF joint inspection. The joint fit-up, per approved drawing CB3002E & CB3002G specifies Mill to Bear. ZPMC was observed closing the gaps with the use of tack welding gusset plates to the floor web plate and using hydraulic jack. ZPMC CWI Huang Ming was present at this time of this observation and informed this QA inspector of the work that is in process. It was stated that ZPMC had 1 welder and identified the welder by ZPMC welder identification number appointed to then by ZPMC.

The following digital picture illustrates work being performed at CB18 temporary lifting Lug assemblies.
